NASA TM X-64086

TEST OF LOX COMPATIBILITY FOR ASPHALT
AND CONCRETE RUNWAY MATERIALS

John F. Kennedy Space Center
Kennedy Space Center, Fla. 32899

December 1973

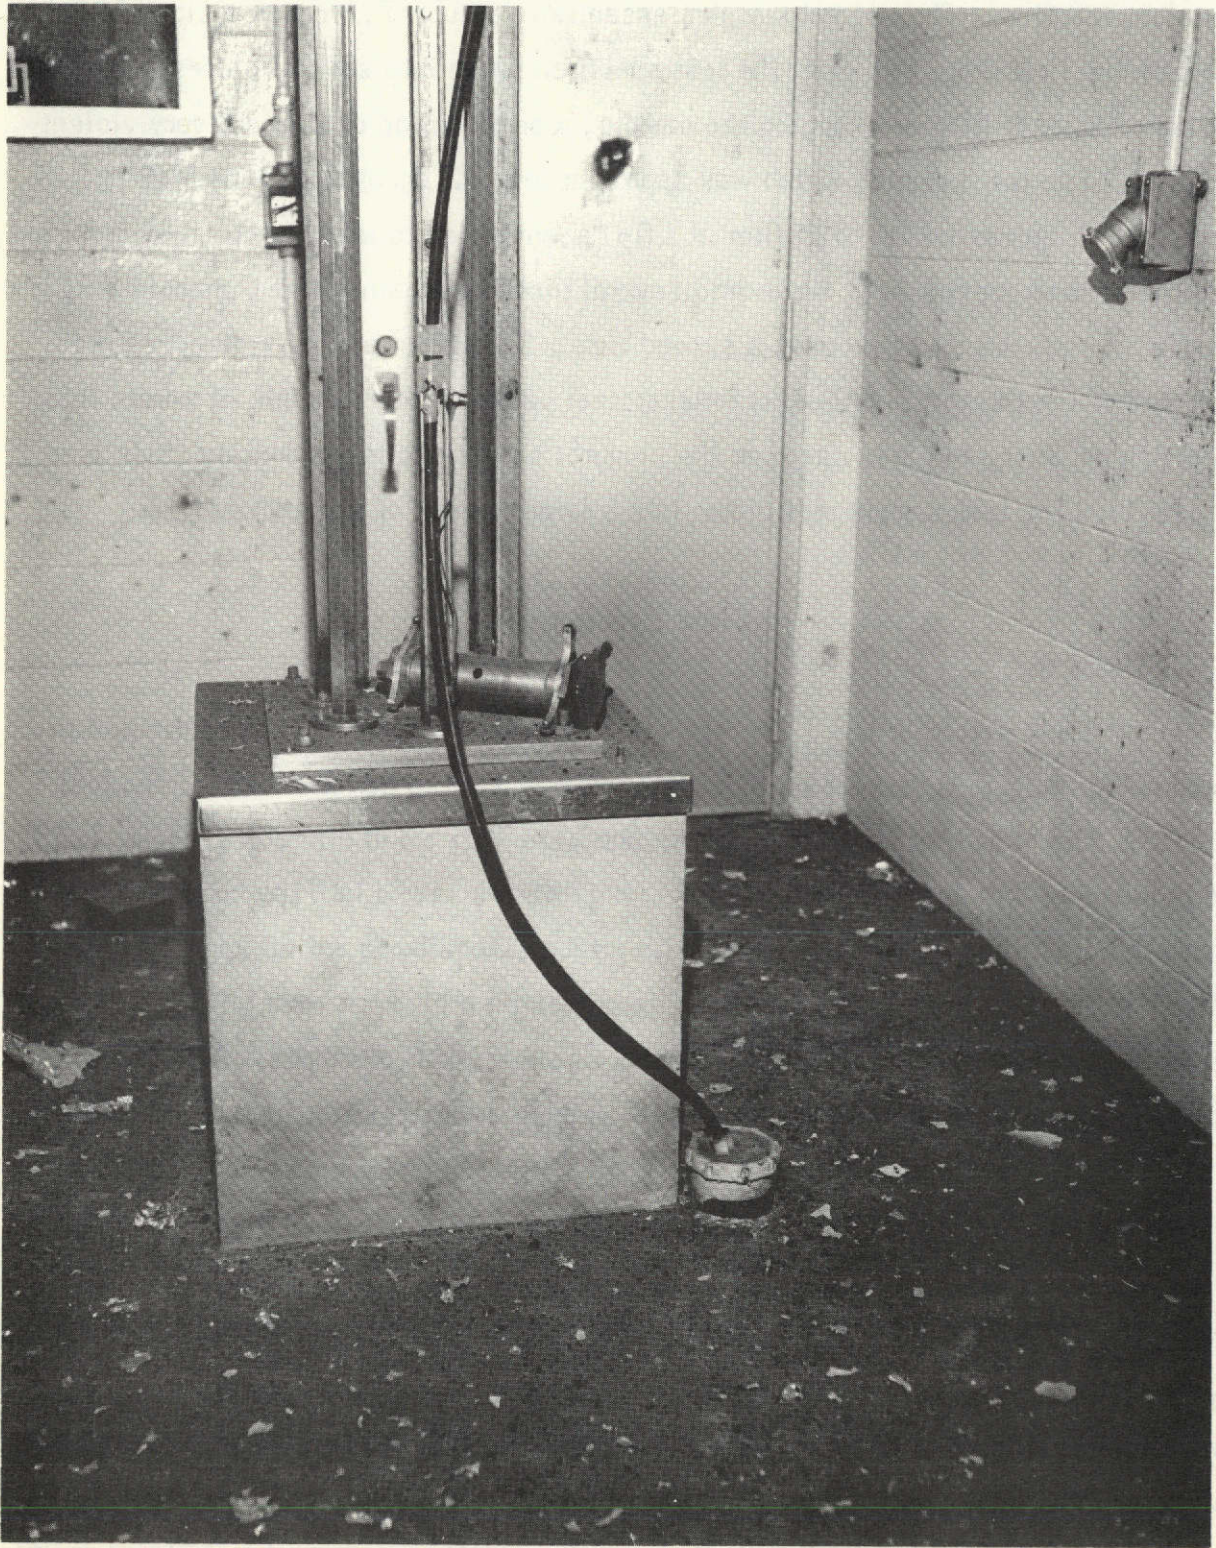
a violent reaction. The second sample, essentially a cube 7.5 cm on a side, failed to react on the first drop; however, the test specimen broke into several pieces. Without adding additional LO_2 or changing the sample, a second drop produced a very violent reaction. The last sample, which was approximately 12 cm by 12 cm by 7.5 cm (immersed in approximately 0.5 liter of LO_2) again failed to react on the first drop; but, like the second specimen, it broke into several pieces. Again without changing the sample, the plummet was dropped a second time. This time another violent reaction occurred which threw a 5.89-kg stainless steel backup plate a couple of meters into an aluminum door, and also damaged the plummet spider and four mounting studs (see Figure 1). The test sample was blown into a large number of tiny pieces.

Figure 1. LOX Impact Test Cell after LOX/Asphalt Reaction.

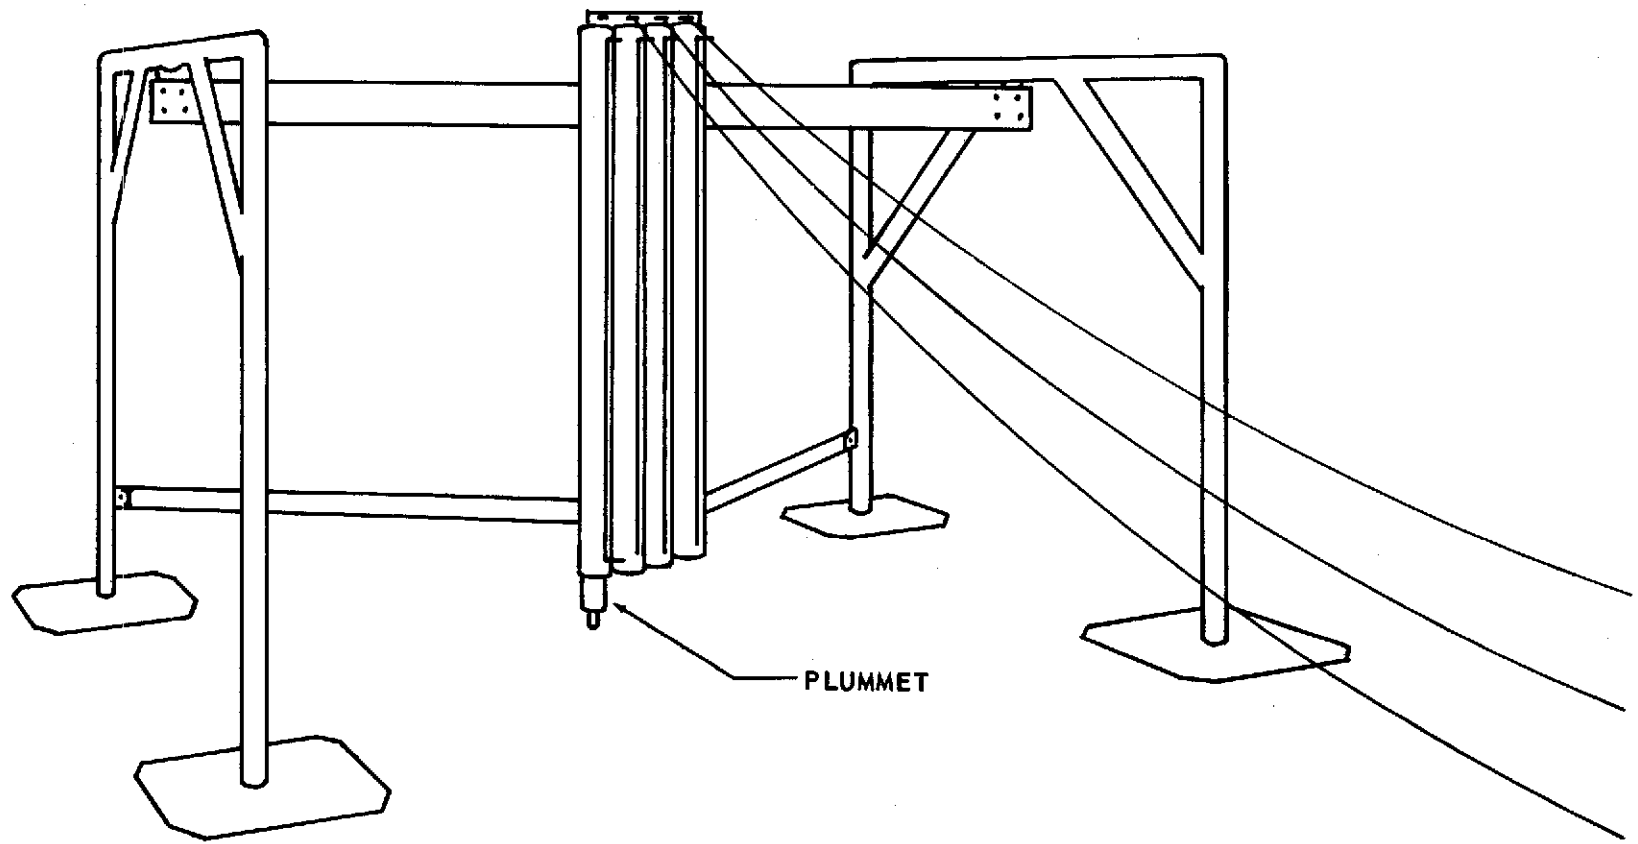
First Trial, Impact. - A test stand, shown in Figure 2, was fabricated to support four plummets, each held by a pin with a lanyard to permit remote individual release. The plummets weighed 9.07 kg and were 7.5 cm in diameter. Tips, 1.27 cm in diameter and approximately 3.8 cm long, were screwed into the bottom of each plummet. Each plummet was provided with a tube extending to within approximately 15 cm of the surface to be impacted. This prevented a plummet from falling over after being dropped and interfering with the impact of subsequent plummets. A rod screwed into the side of each plummet and extending through a vertical slot in each tube provided a handle by which the plummet could be raised to the top of its tube to be secured by a release pin. A slab of used asphalt pavement 2 meters square and approximately 5 cm thick was installed at the test site and an asphalt curb 7.5 cm high was built around its edge. The test stand was assembled over the slab with its feet level with the asphalt surface. A ring of flex line, perforated on the bottom, was coupled to the LO_2 delivery line and positioned over the middle of the slab. The slab was sponged dry to remove rainwater, and then a trial flow of LN_2 was performed. Three days later a 400 frame per second movie camera was installed, rainwater was again sponged from the slab, and 12 empty 0.5 liter aluminum beer cans were placed as shown in Figure 3 as blast

Figure 2. Impact Test Stand.

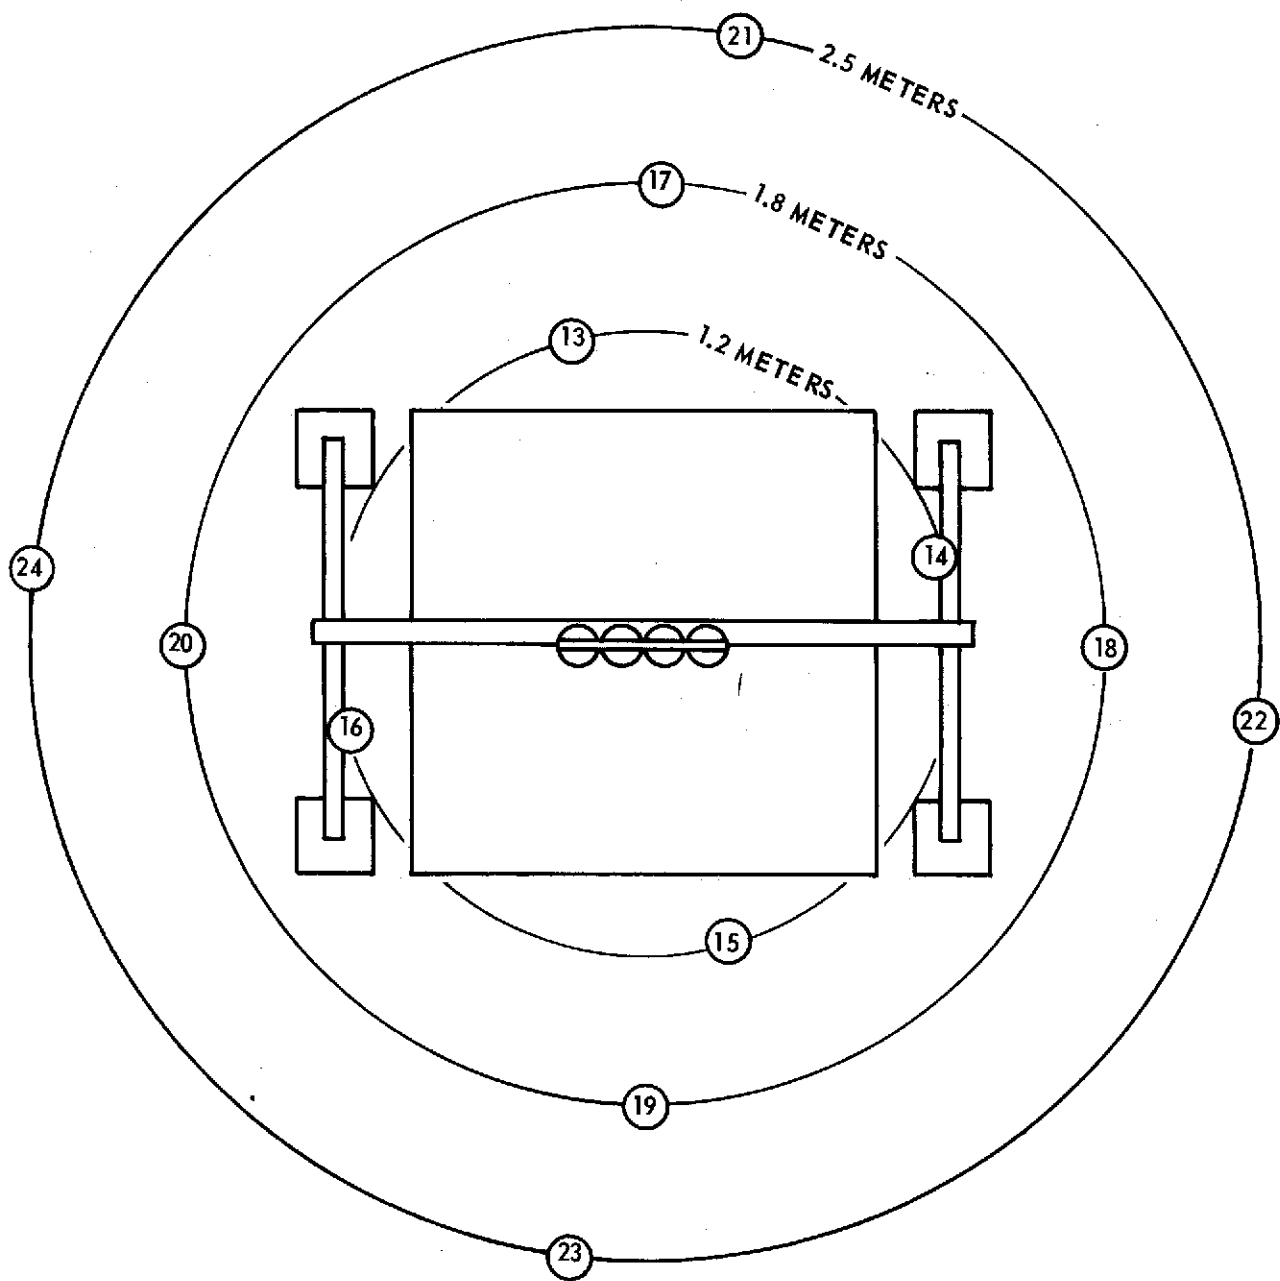
Figure.3. Blast Sensor Location, Impact.

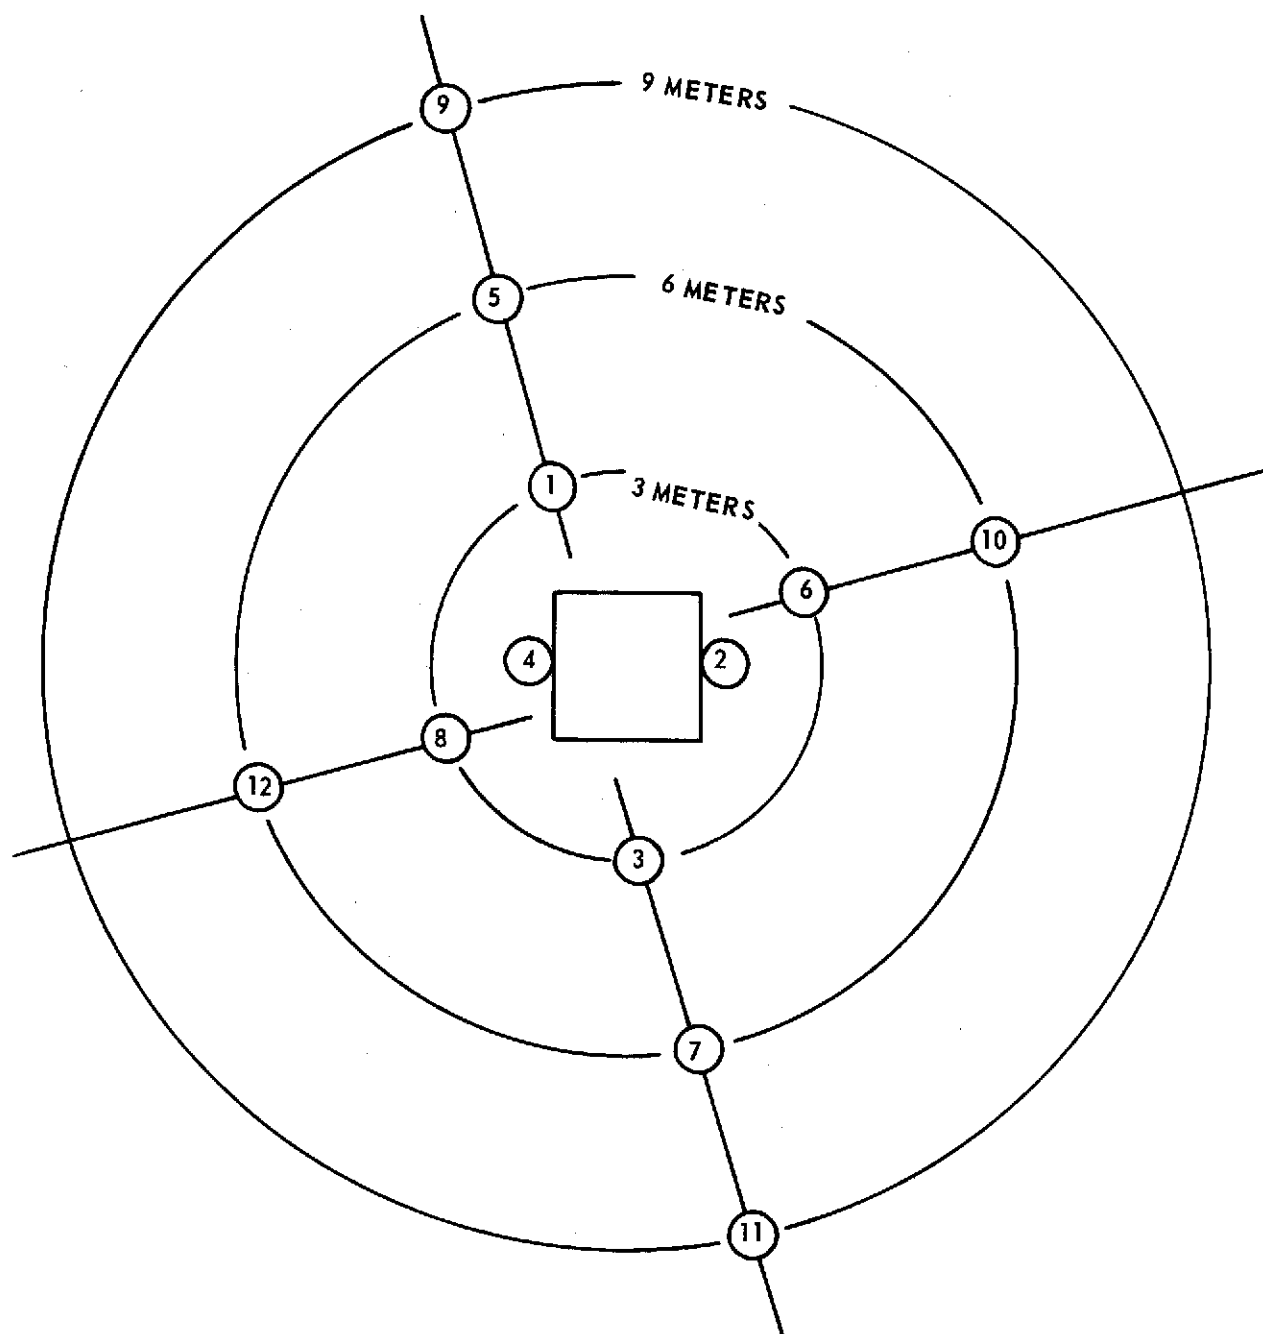
Figure 4. Blast Sensor Location, Blasting Cap.

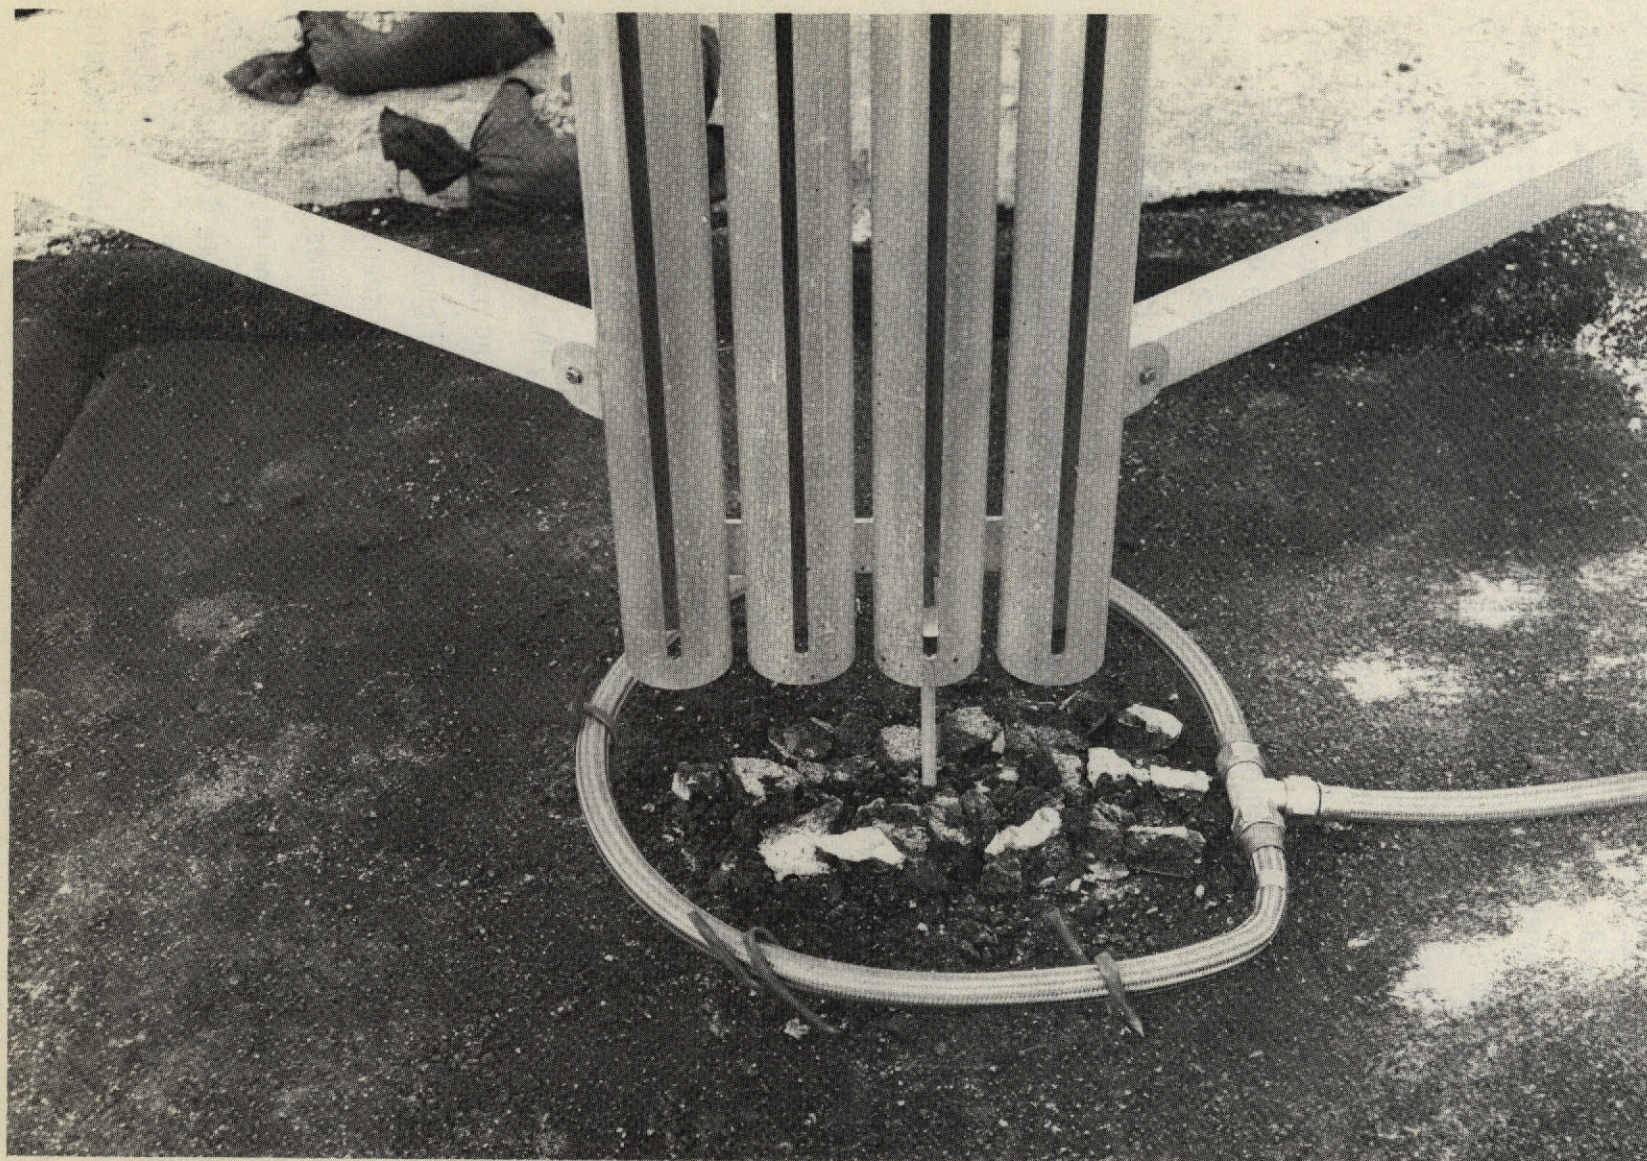
Sixth Trial, Impact. - The test stand was then removed, and a trench about 50 cm long, 10 cm wide, and 1.2 cm deep was chiseled in the asphalt. In the position where the second plummet would strike, an additional cavity was excavated to accommodate a 2.5-cm thick aluminum block, 9 cm wide and 10 cm long. The block was firmly seated with its top surface slightly below the level of the slab surface. A mixture of broken old and new asphalt pavement, ranging from small pea size to large nut size, was piled in the trench and tamped by foot. The pile was from 1 to 2 cm above the slab surface. The test stand was then repositioned. No change was made in the plummet tips, but a striker pin, consisting of a 1.2-cm threaded rod about 22 cm long, with a 7.5-cm teflon disc at the top was placed on the asphalt under the third plummet, with the disc inside the tube to support it. Figure 5 shows the impact points prepared for this trial. Beer cans were positioned as shown in Figure 2. LO_2 was allowed to flow for 10 minutes, the camera switch was activated, and the first plummet was released, with no reaction. The second plummet was then released, and a detonation occurred. The test stand was destroyed, and it is estimated that pieces of it rose 30 meters in the air. When the test site was inspected, it appeared that a reaction had occurred over the entire slab surface, but only a small proportion of its material has been consumed to an estimated depth of 2.5 cm. The reaction appeared to have initiated at two points, above and below the aluminum block. The plummet tip impression in the aluminum block was several times deeper than one made by simply dropping the plummet from the same height. A cavity was found in the asphalt under the position occupied by the aluminum block. It was found that the camera had not been actuated by the switch, and no film of the reaction is available. Still photographs were made of the debris in situ. Figures 6 and 7 show the impact site. In Figure 7, the outline of the asphalt slab can be seen. Fragments have been assigned identification numbers 1 through 33. Figure 8 shows fragments 16, 17, and 18 at a distance of approximately 30 meters from the impact point. Figure 9 shows fragment 15, approximately 9 meters from the impact point. Figure 10 shows a plummet, fragment 28, approximately 12 meters from the impact point. Figure 11 shows a leg, fragment 22, approximately 47 meters from the impact point. Although the holding pond was contaminated, two objects were retrieved from it: the first plummet, and the

Figure 5. Points of Impact Prepared for Sixth Trial.

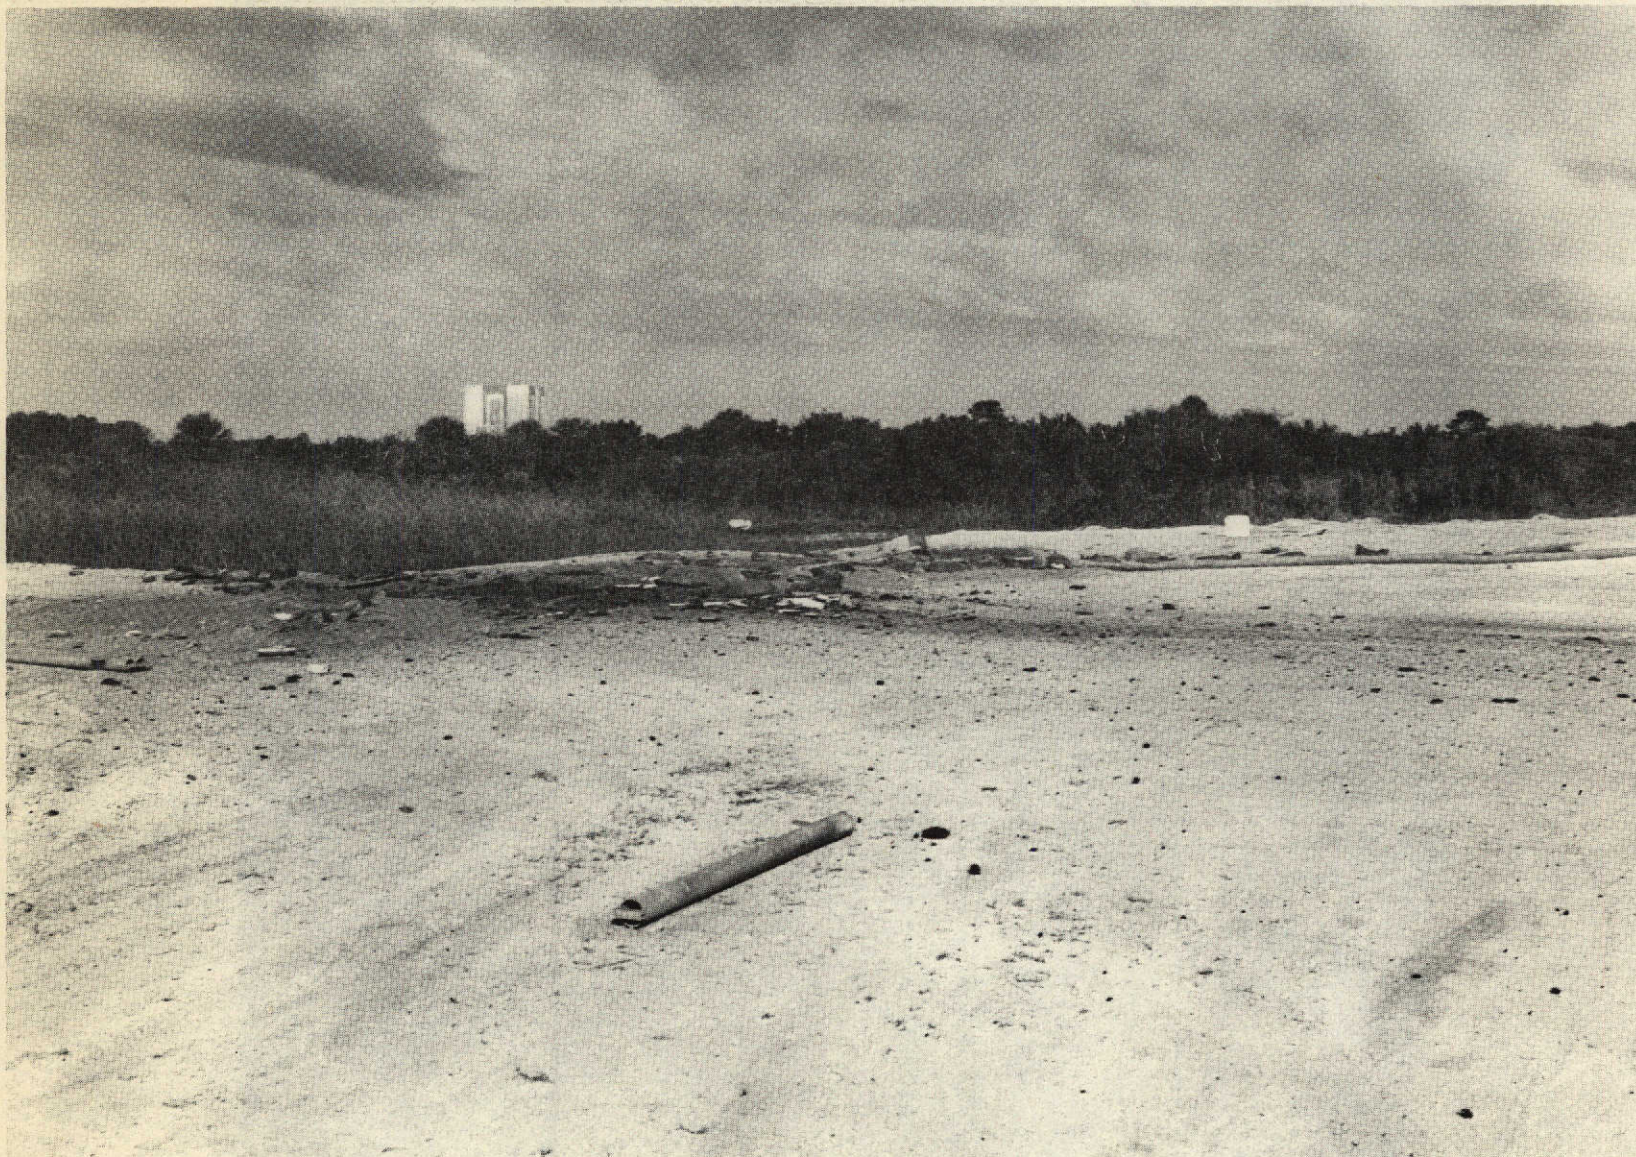
Figure 6. General View, Impact Site after Detonation.

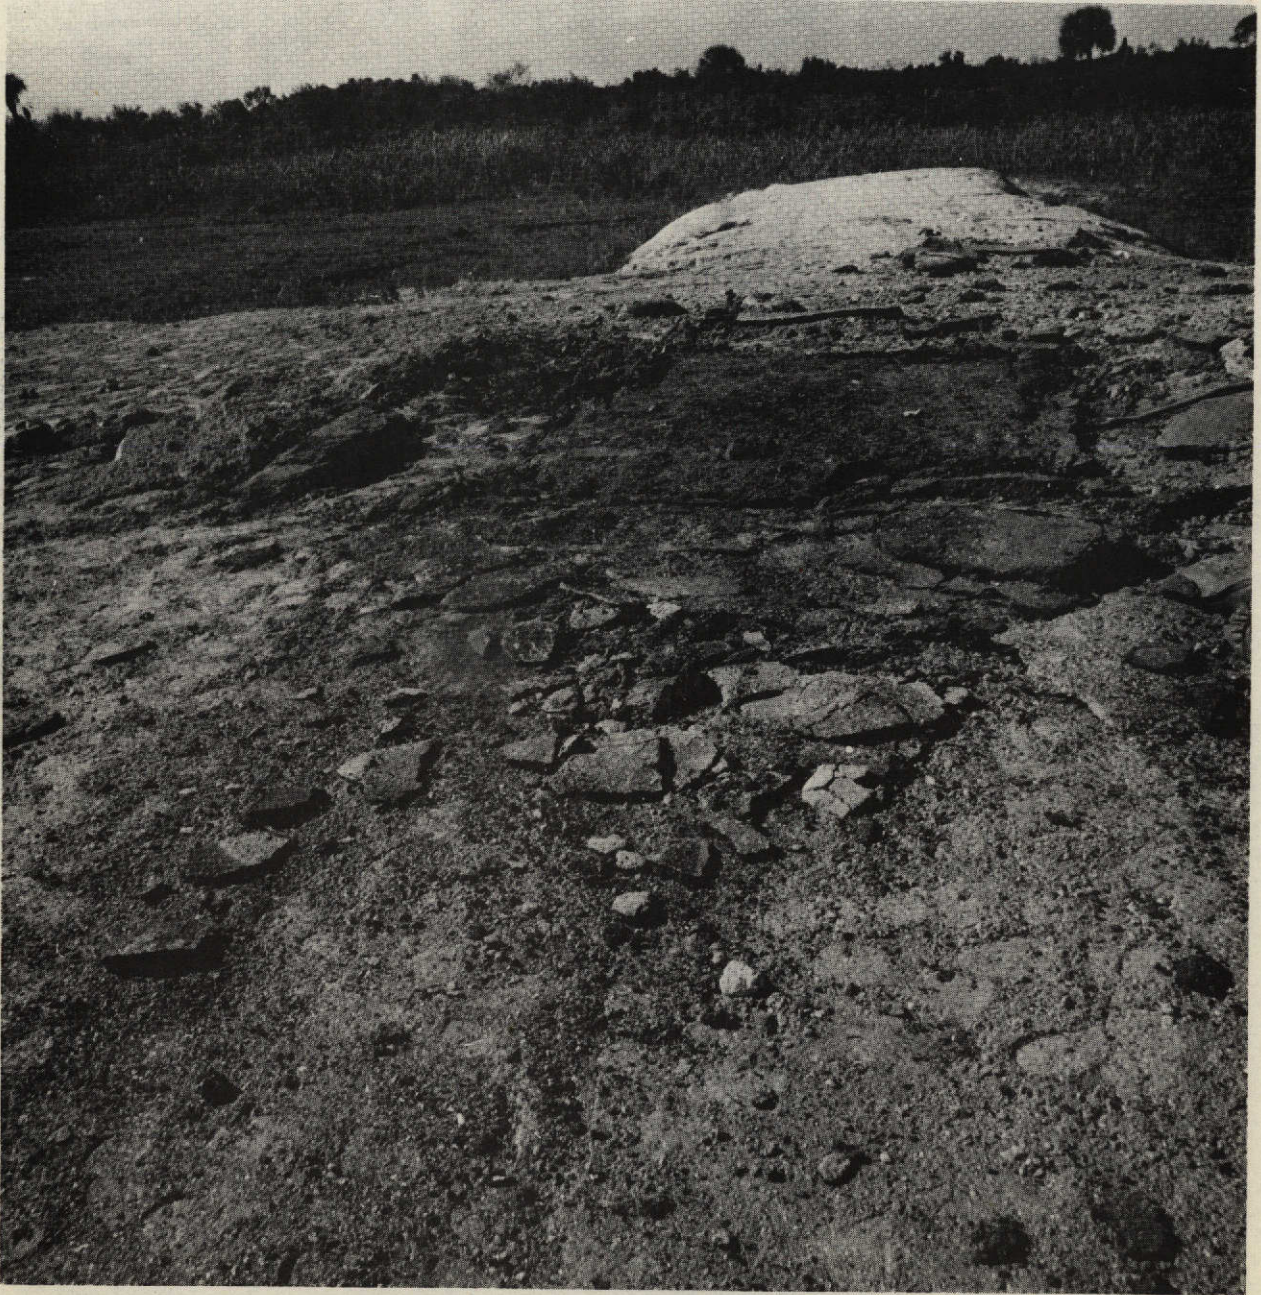
Figure 7. Impact Site, View from East.

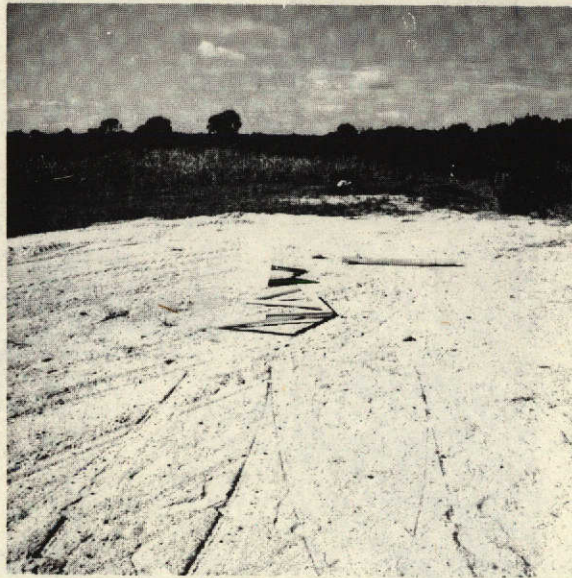
Figure 8. View to North. Fragments 16,
17, and 18.

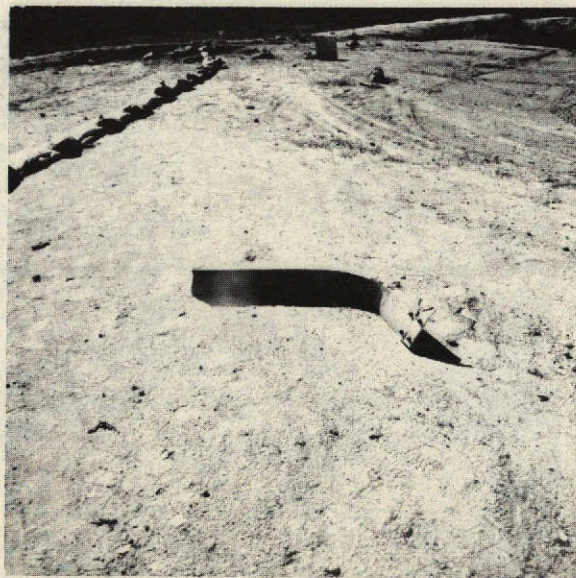
Figure 9. View from Northeast.
Fragment 15.

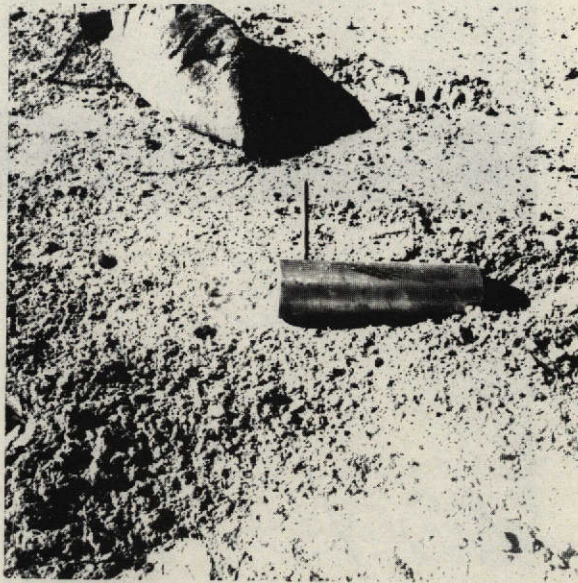
Figure 10. Plummet, Fragment 28.

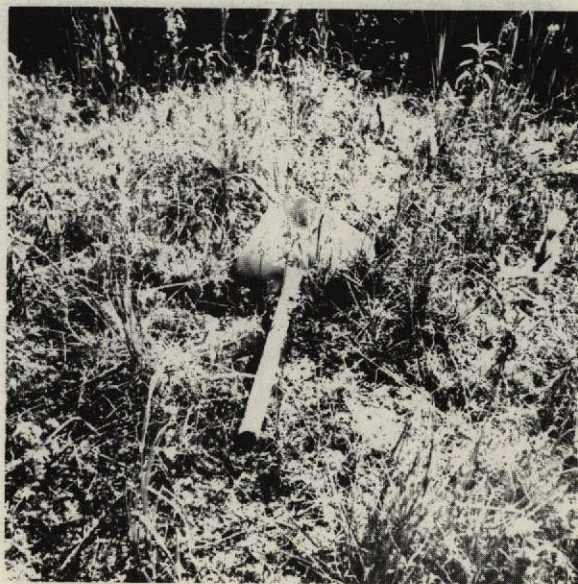
Figure 11. Leg, Fragment 22.

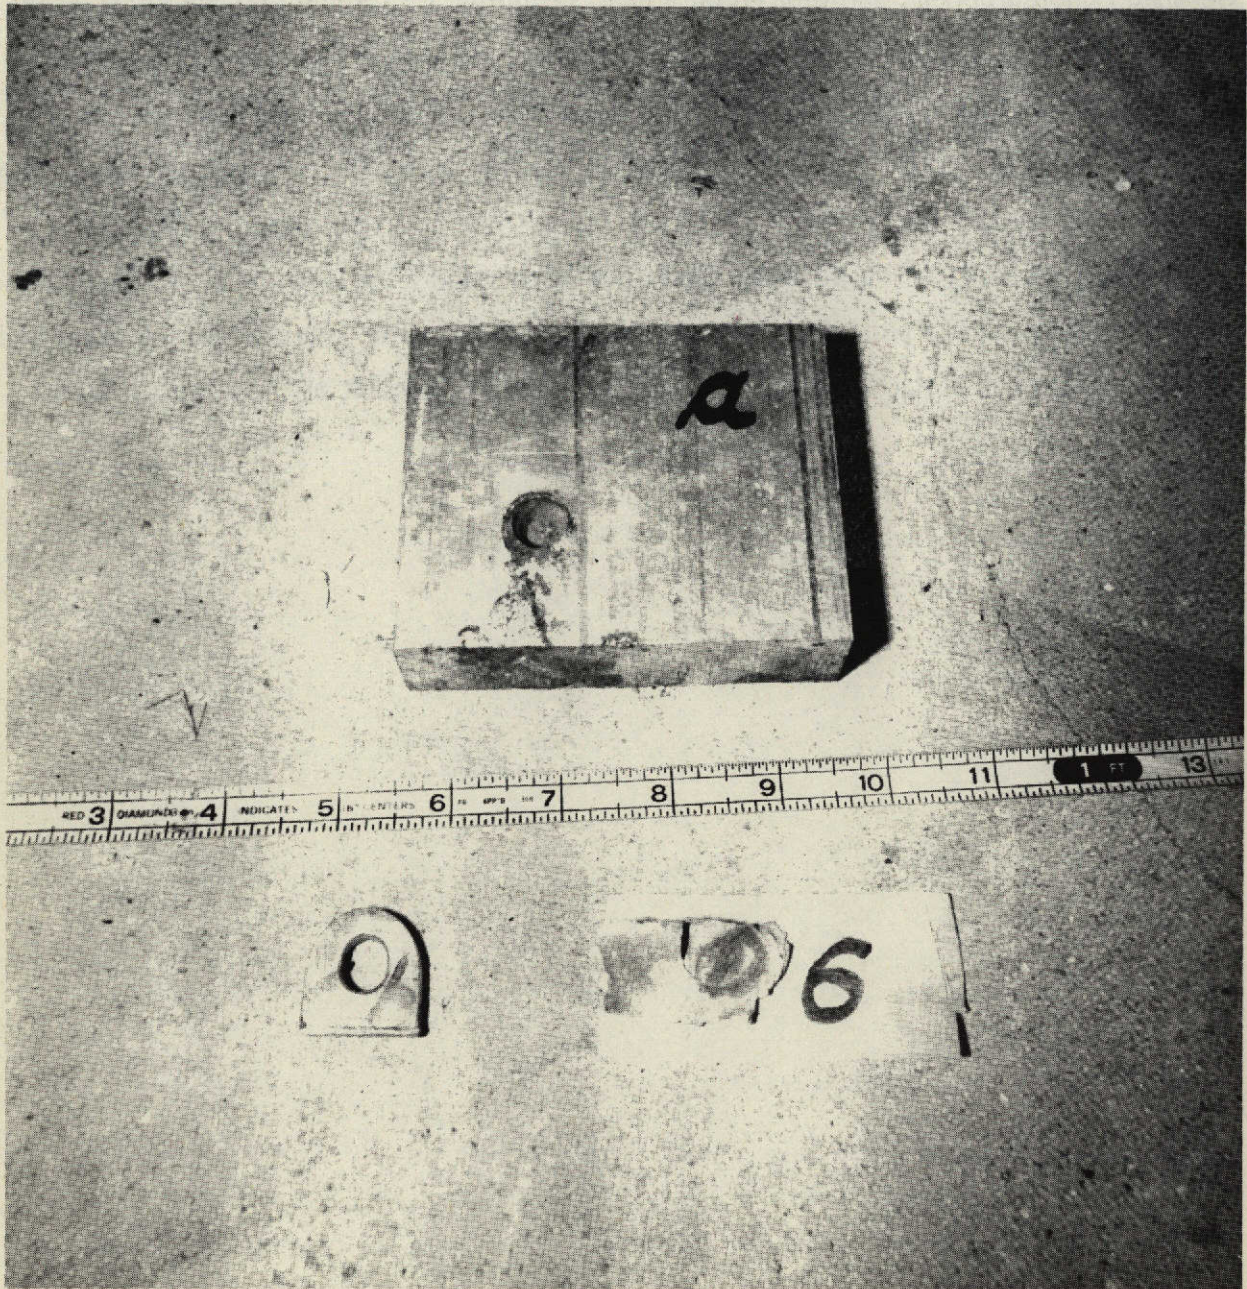
aluminum block which had been placed under the second plummet. The block (a, Figure 12) was approximately 18 meters at 92° from the impact point. The plummet was approximately 33 meters at 94° from the impact point. The fragments were then located, collected, weighed, photographed, and plotted on a map. Figures 13 through 19 are photographs made at that time showing representative fragments. Figure 20 is a map of the area, showing the position of fragments after the detonation. Table 2 shows the weights, distances, and azimuths for the fragments. In the last trial, three conditions were different from those of the previous trials: first, the asphalt had dried out during a dry, warm week-end before this trial, while all other trials had been made after wet slabs were sponged dry; second, asphalt at the point of impact was broken, presenting a larger surface area; and third, an aluminum block was placed beneath the broken asphalt at the point of impact.

Figure 12. Aluminum Block.

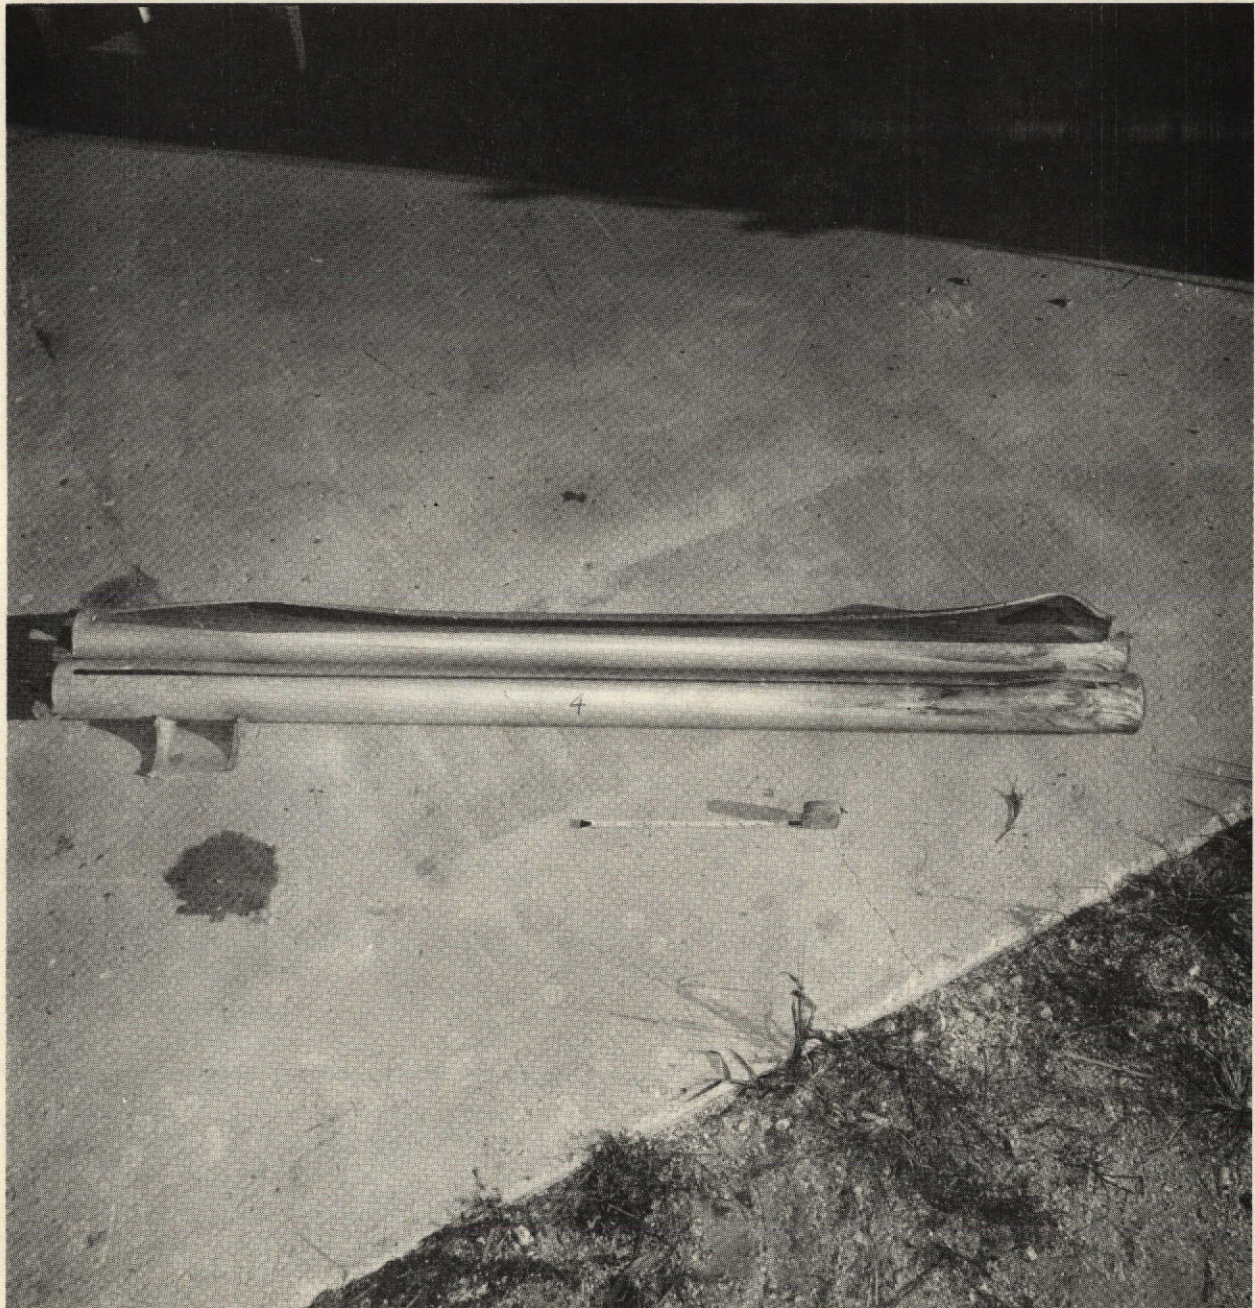
Figure 13. Guide Tubes, Fragment 4.

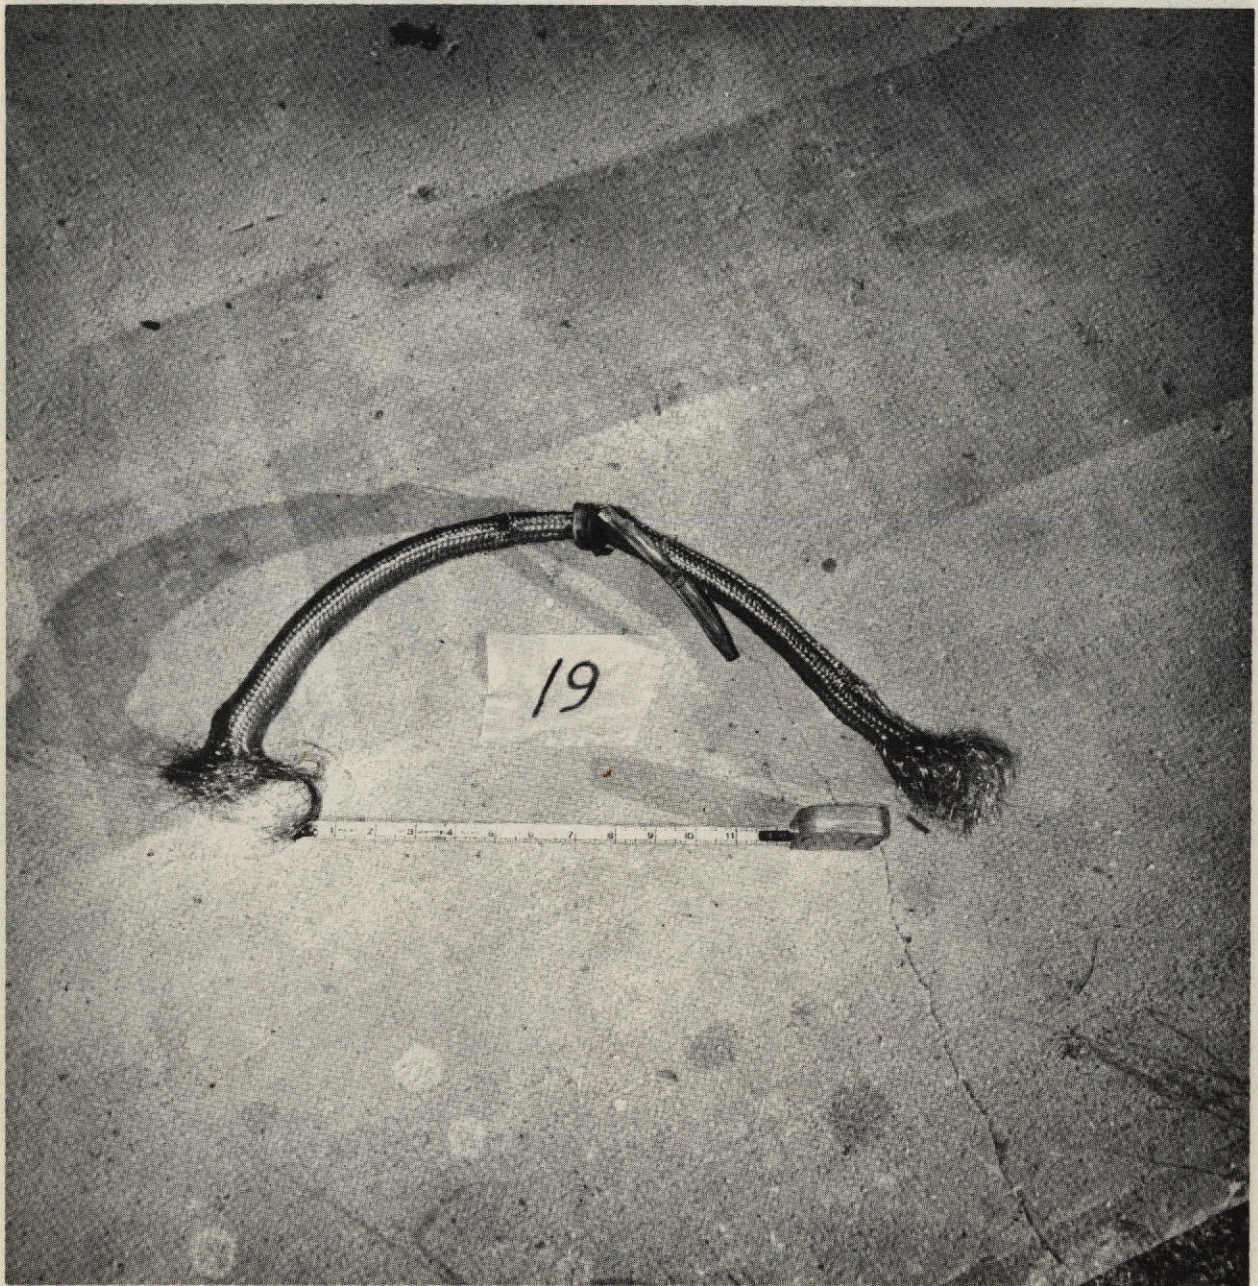
Figure 14. Flex Hose, Fragment 19.

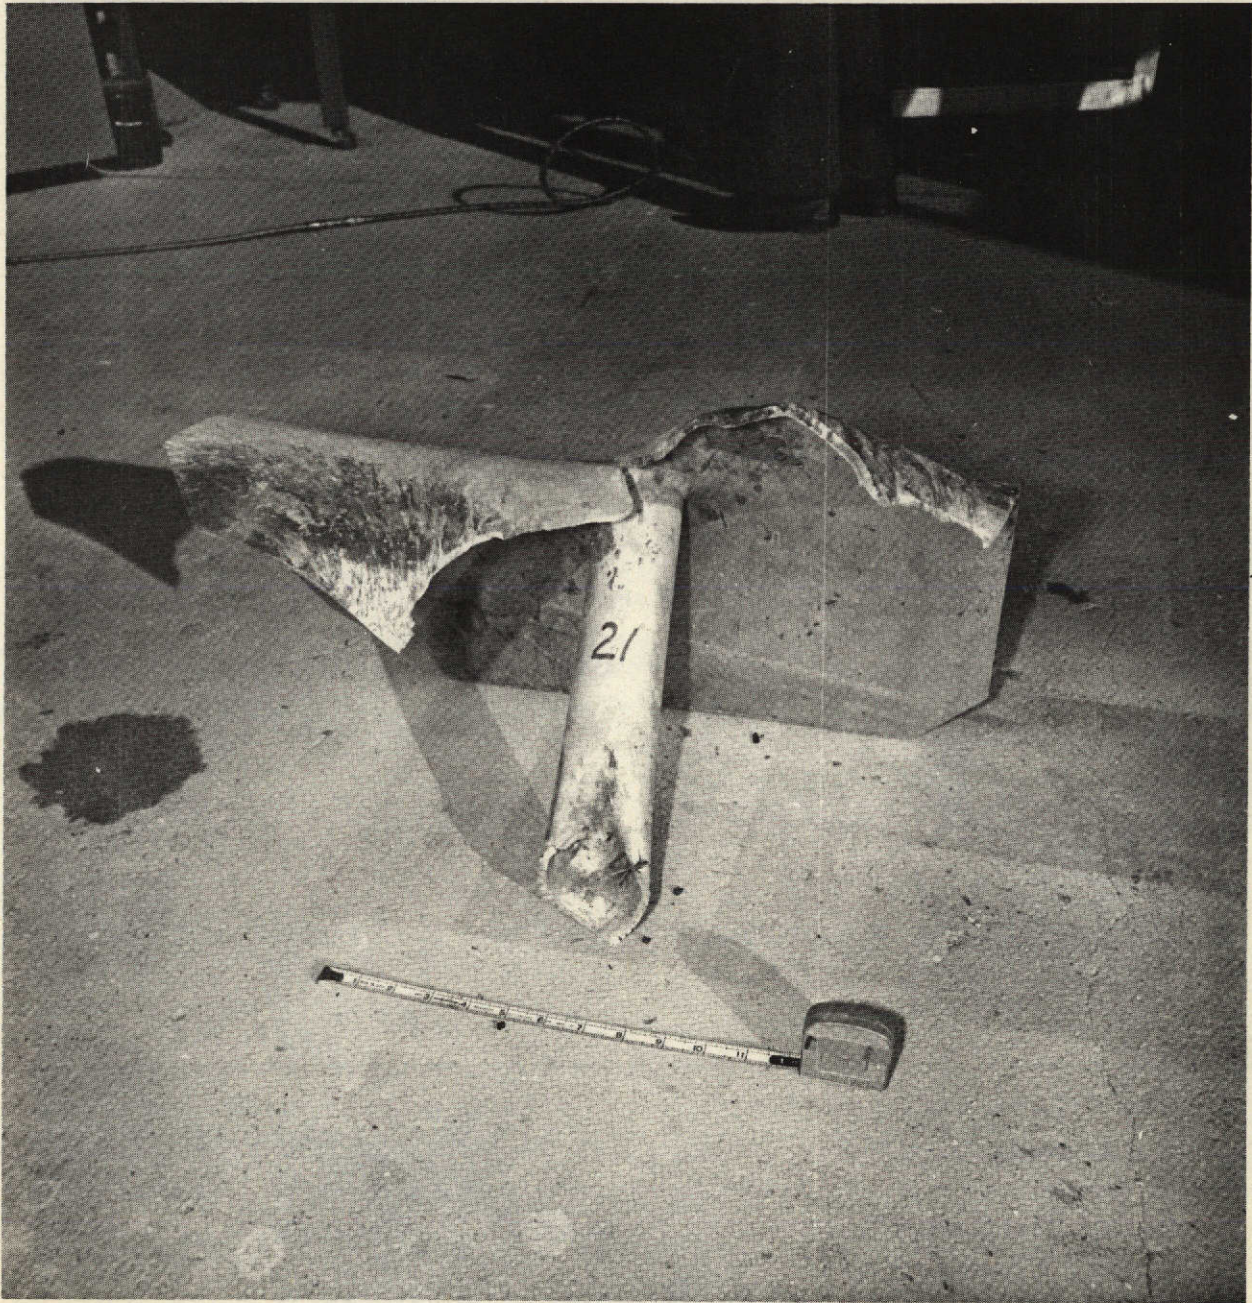
Figure 15. Leg, Fragment 21.
